Vila D'Este neighbourhood, Vila Nova de Gaia (Portugal)

Title of case study: Vila D' Este

Year and duration of the renovation: 2009-2015

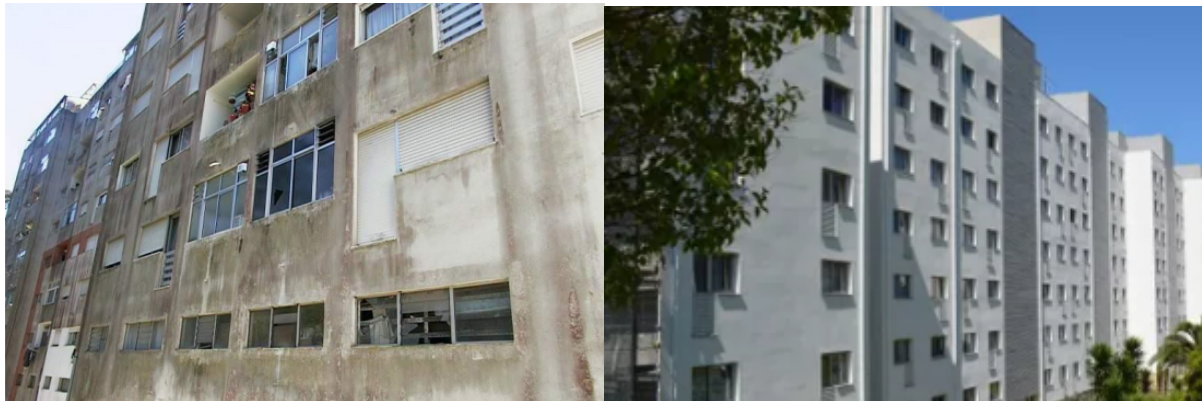
Before the renovation intervention, there was a general deterioration of the façade materials, mainly due to the absence of maintenance and repair measures. The anomalies consisted of low indoor thermal comfort, poor ventilation, presence of water infiltration and condensation, which have a negative impact on the durability of the building components and indoor air quality.

*Figure 2. Façade in Vila D'Este district before renovation (left) and after renovation (right).
Source: Gaiurb, from: <http://www.cm-gaia.pt/fotos/editor2/a-nova-vila-deste.pdf>.*

- Execution of metallic coating type "Roofzip¹";
- Introduction of 8 cm thick layer of rockwool insulation and windshield vapour barrier, heat transfer coefficients of 0.39 W/m² °C and 0.38 W/m² °C, for upward and downward airflow, respectively;
- Application of Aeolian² fans on top of the ventilation conducts of sanitary facilities.

- Application of a 5 cm thick layer of thermal insulation in external walls with expanded extruded polystyrene (ETICS), heat transfer coefficients of 0.59 W/m² °C;
- Installation of panels and flaps in GRC (Glass Fibre Reinforced Cement);

- Replacement of window areas in buildings' entrance doors, stairwells and storerooms;
- Installation of shading elements in window areas.
