DEEP ENERGY RETROFITS

AIR TIGHTNESS OF EXISTING BUILDINGS

Wagdy Anis, FAIA, LEED AP

Retrofit Air Barriers in Existing Buildings

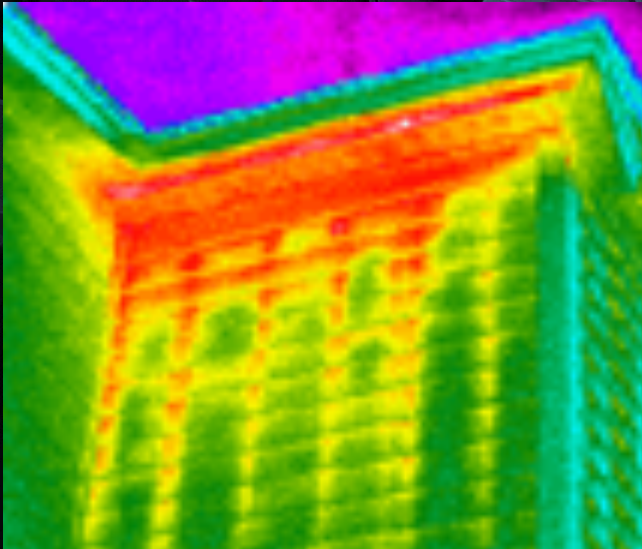
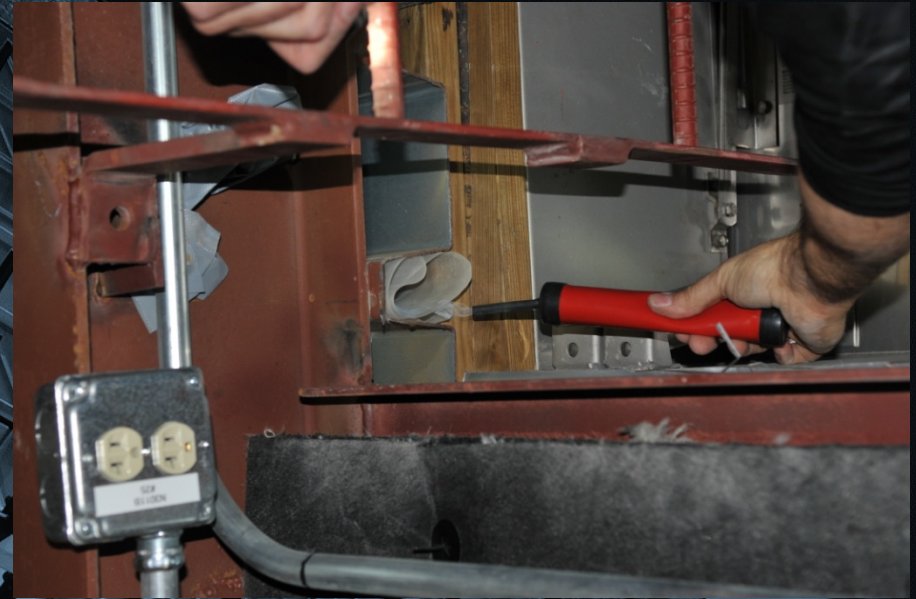
Air Barrier Continuity

- ASTM E1186, Standard Practices for Air Leakage Site Detection in Building Envelopes and Air Barrier Systems

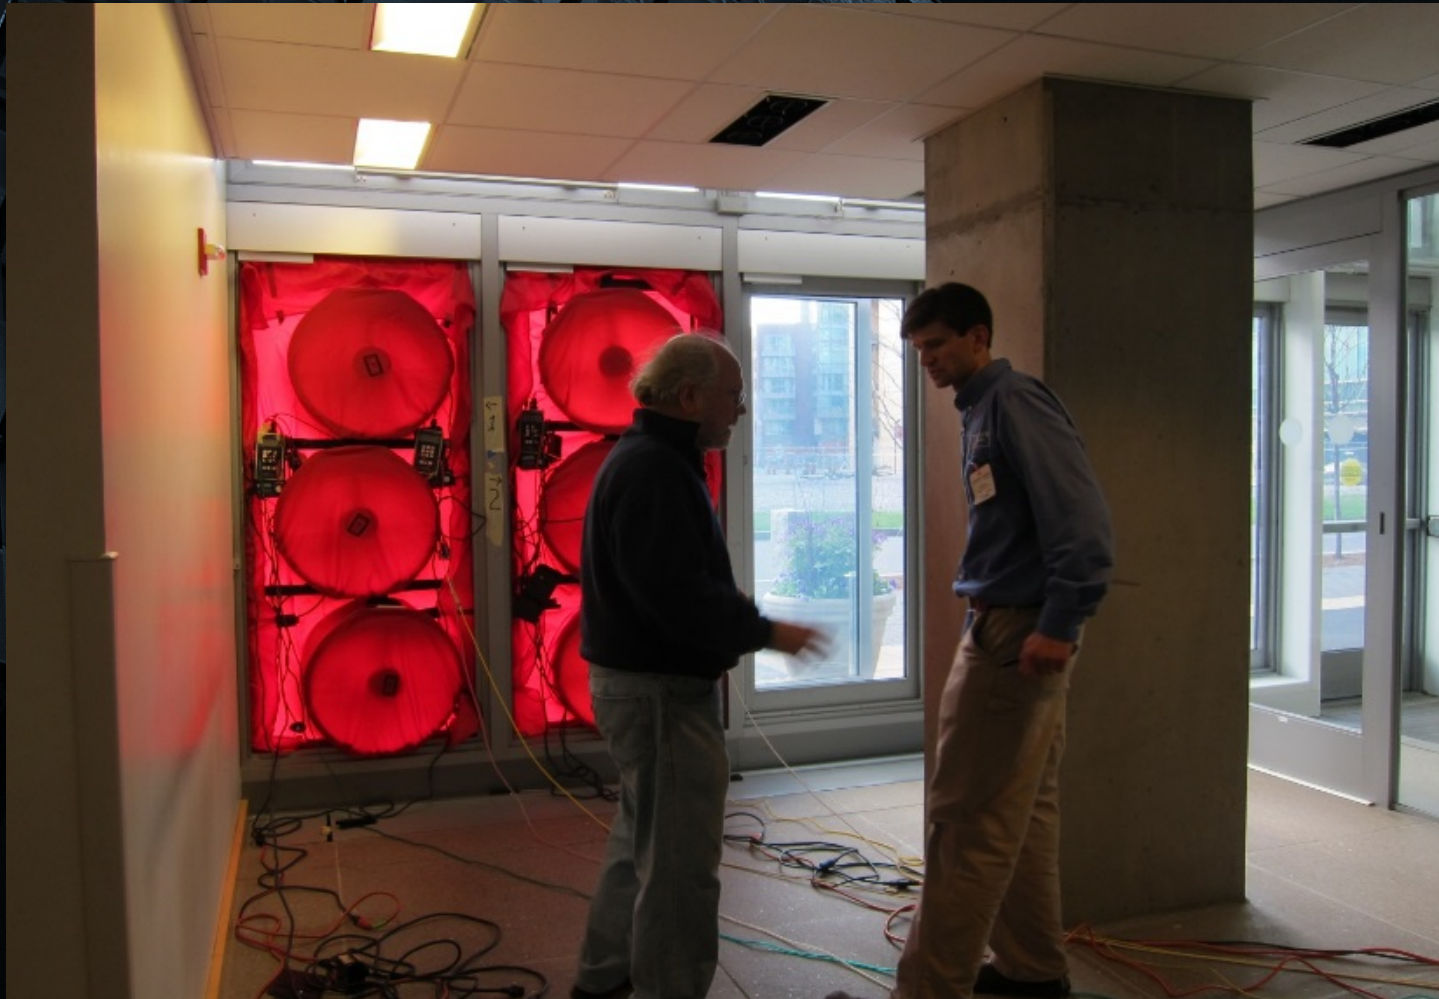
- Depressurization testing
- Locating air leakage
 - Infrared thermography
 - Tracer gas testing or theatrical smoke

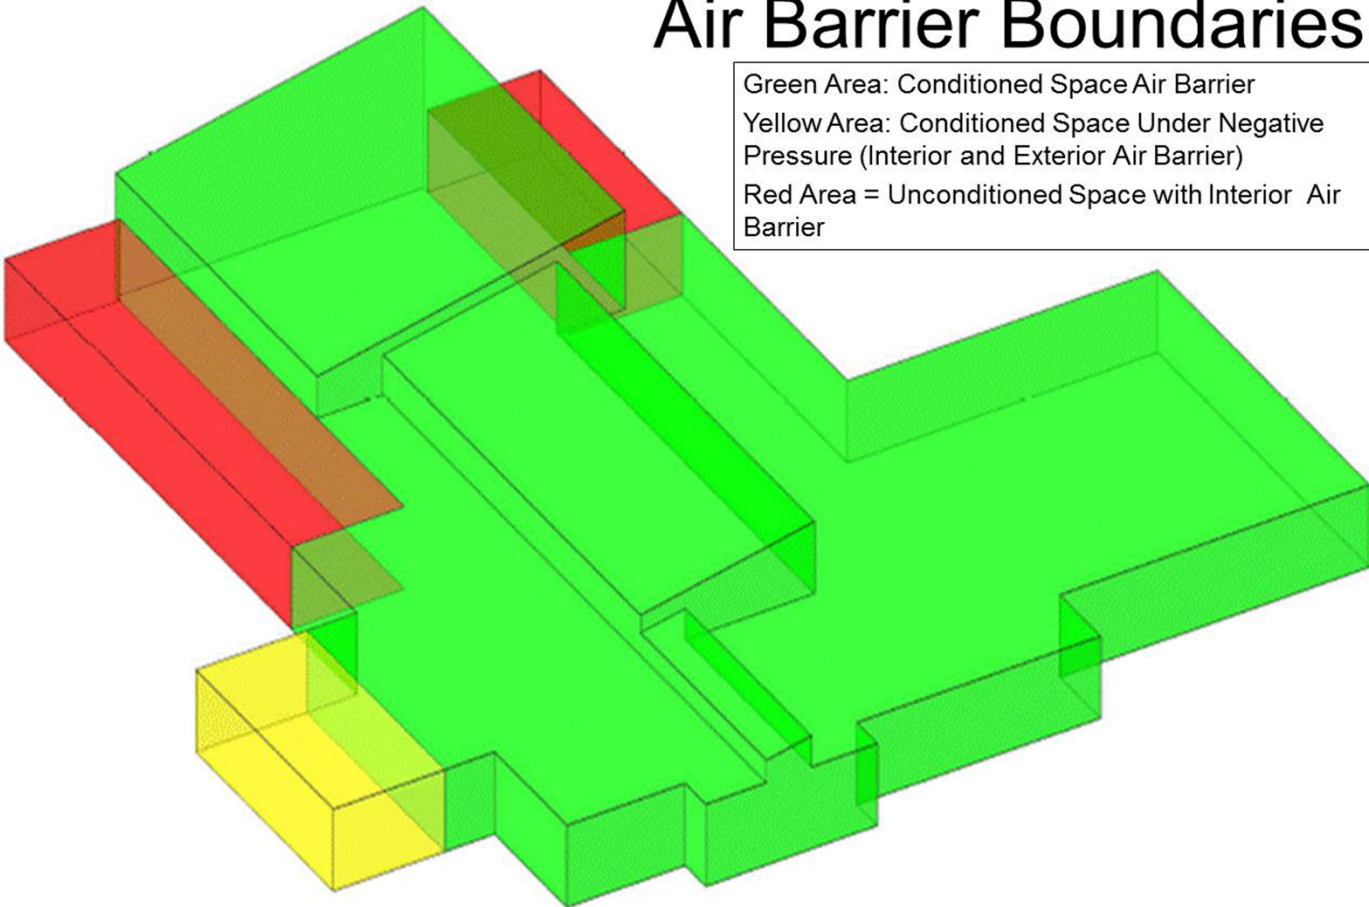
Air Barrier Boundaries

Green Area: Conditioned Space Air Barrier
Yellow Area: Conditioned Space Under Negative Pressure (Interior and Exterior Air Barrier)
Red Area = Unconditioned Space with Interior Air Barrier

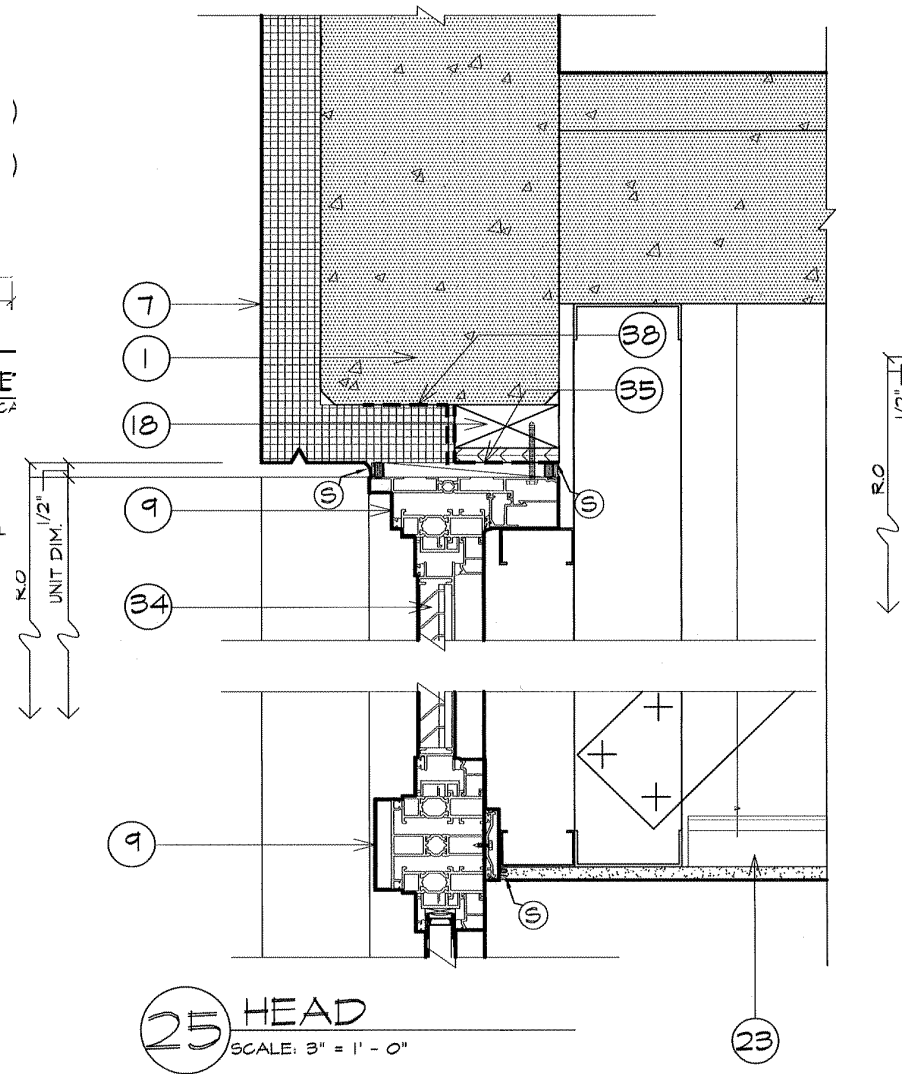
Gut Renovation
Façade restoration
Interior air barrier

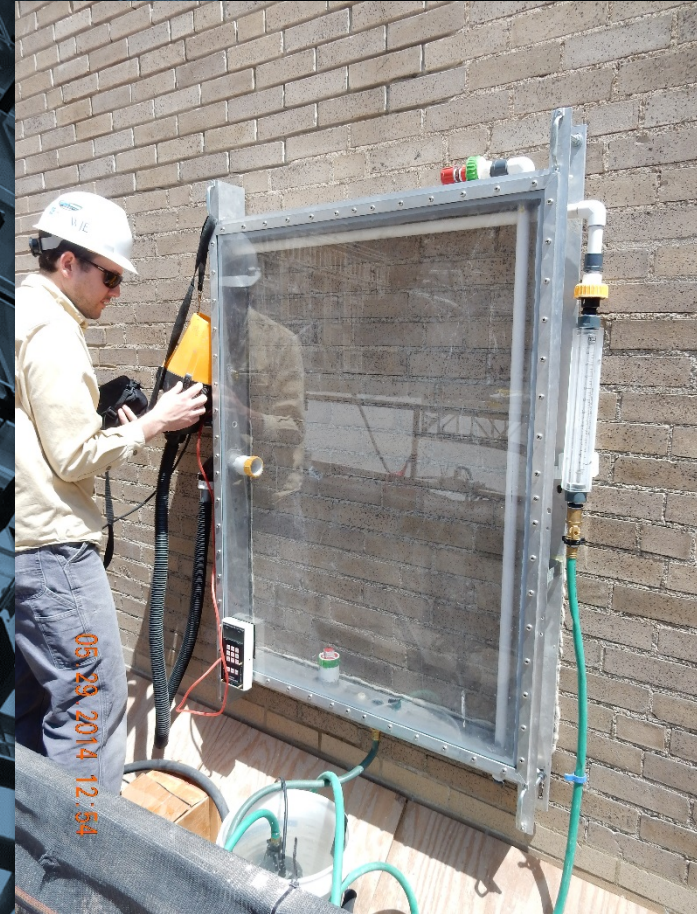
Field Testing and In-situ Monitoring

- Local climate and rain water conditions.
- Absorption (Rilem tube, ASTM C1601)
- Water penetration
- Air leakage

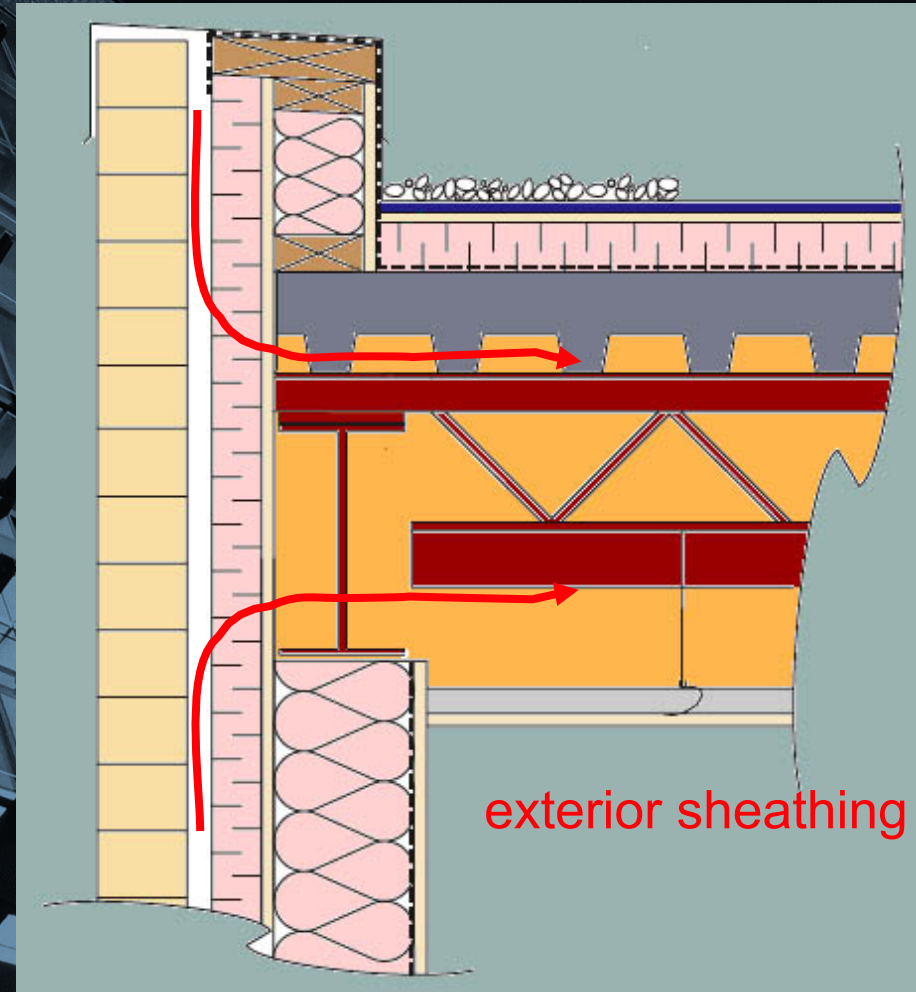
Air Barrier Continuity

- The plenum
 - Air can infiltrate through many different assemblies if air barrier systems are not in place

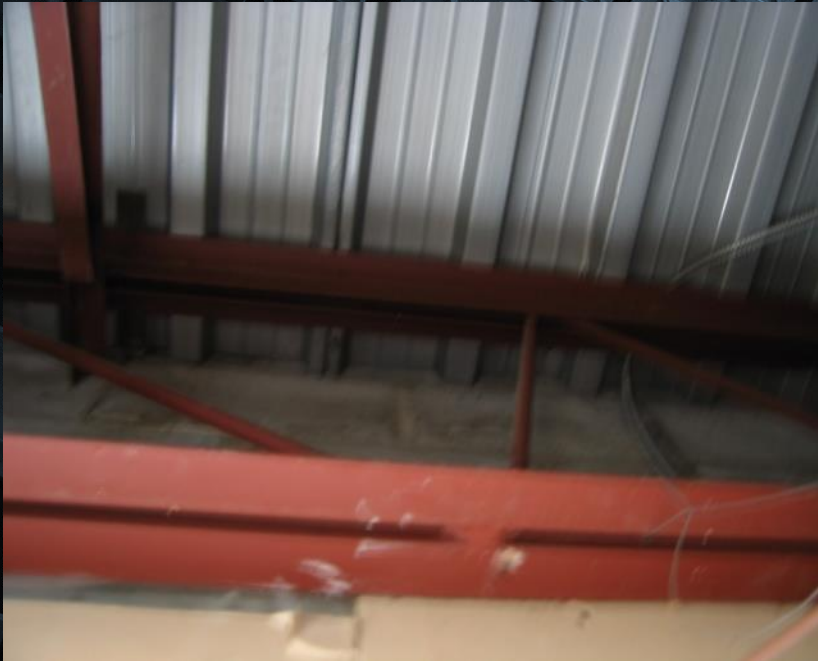
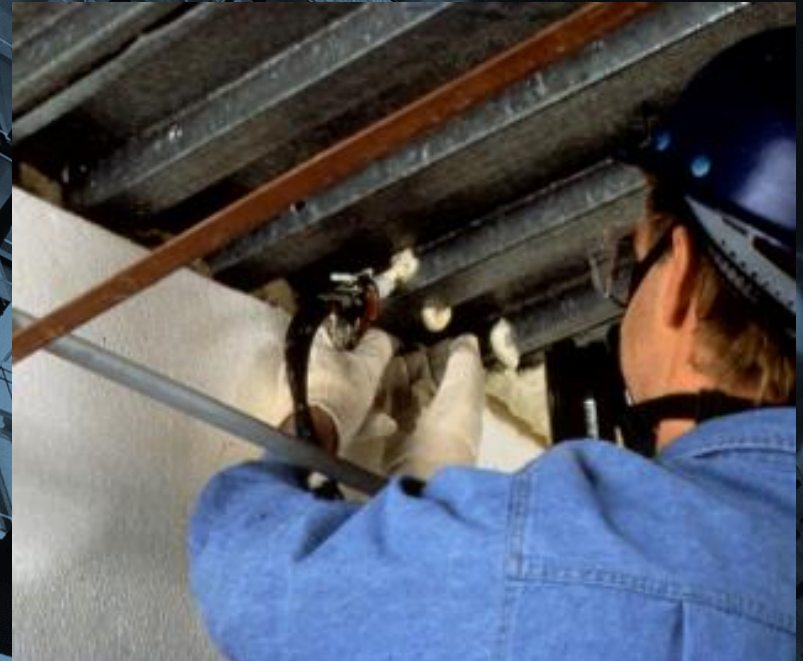
Seal top of building

- Reroofing AVB
- Attics
- Roof/wall intersections and plenum spaces
- Mechanical penthouse doors and walls
- HVAC equipment penetrations through the roof
- Other roof penetrations, such as plumbing vent stacks

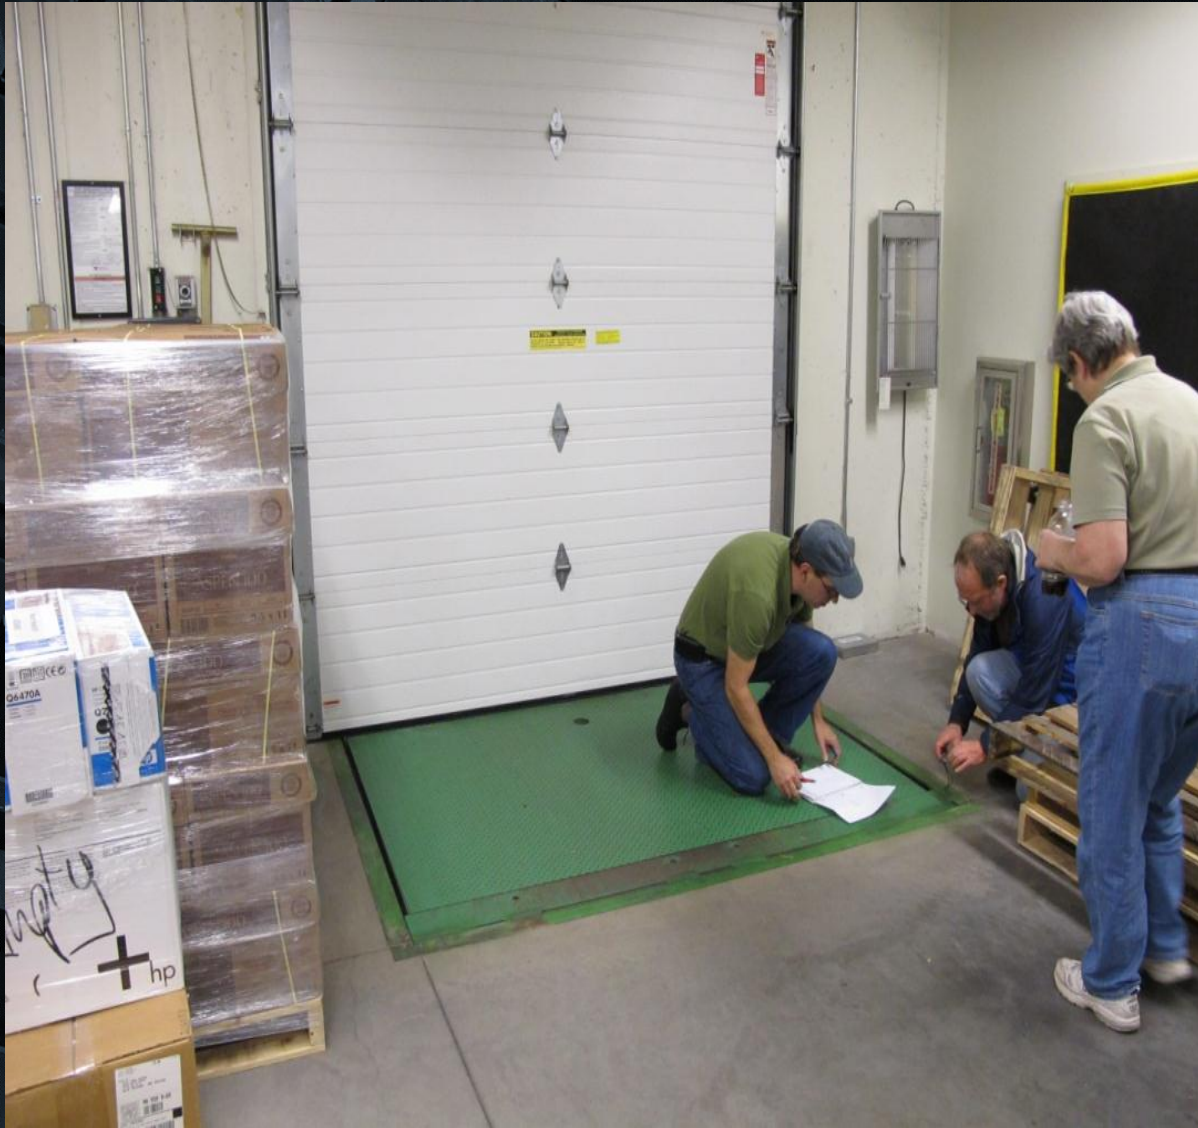
Bottom of Building

- Exterior soffits, canopies and ground floor access doors
- Underground parking access doors and elevators
- Exhaust and air intake louvers and vents
- Pipe, duct, cable and other service penetrations into core and shafts of building
- Sprinkler head penetrations, inspection access doors and hatches.
- Seal core wall to floor slab
- Residential crawl spaces and penetrations, vented or unvented.
- Loading docks

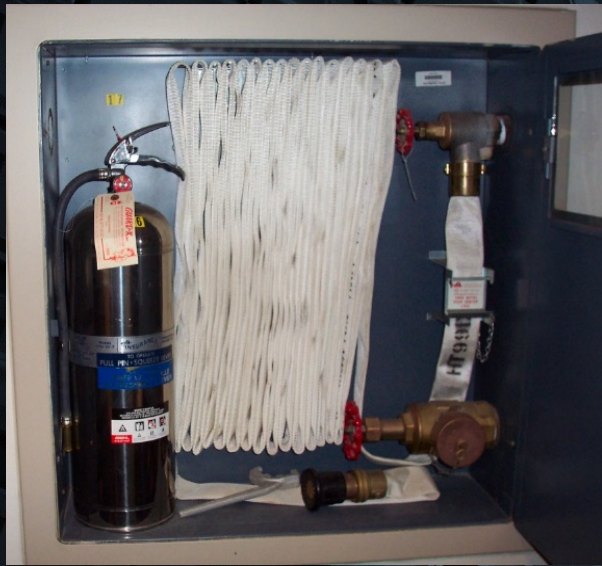
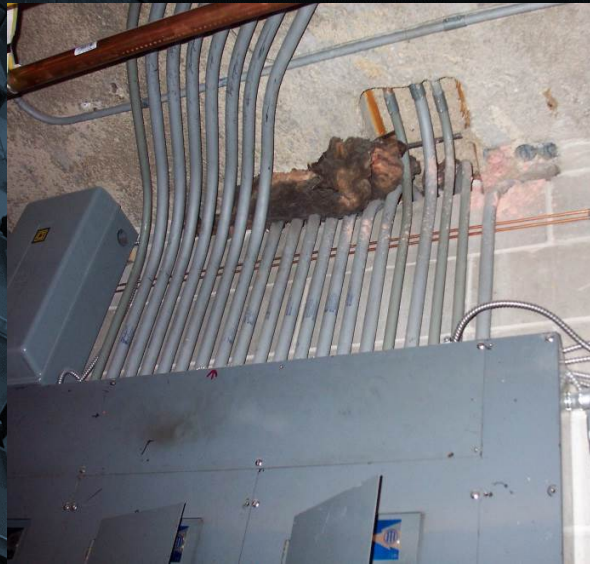
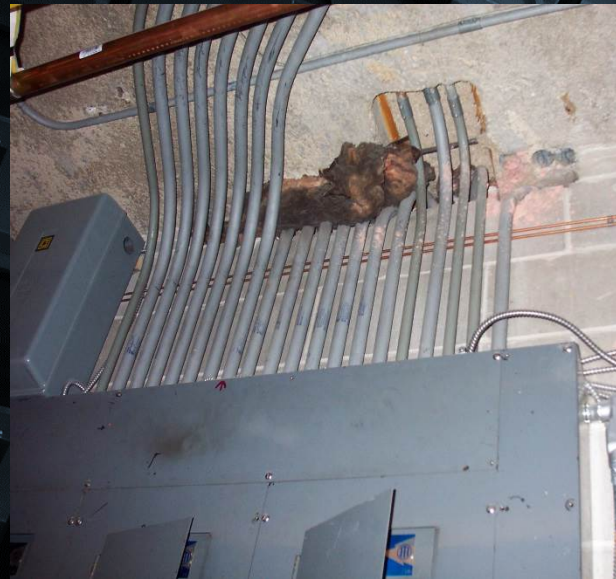
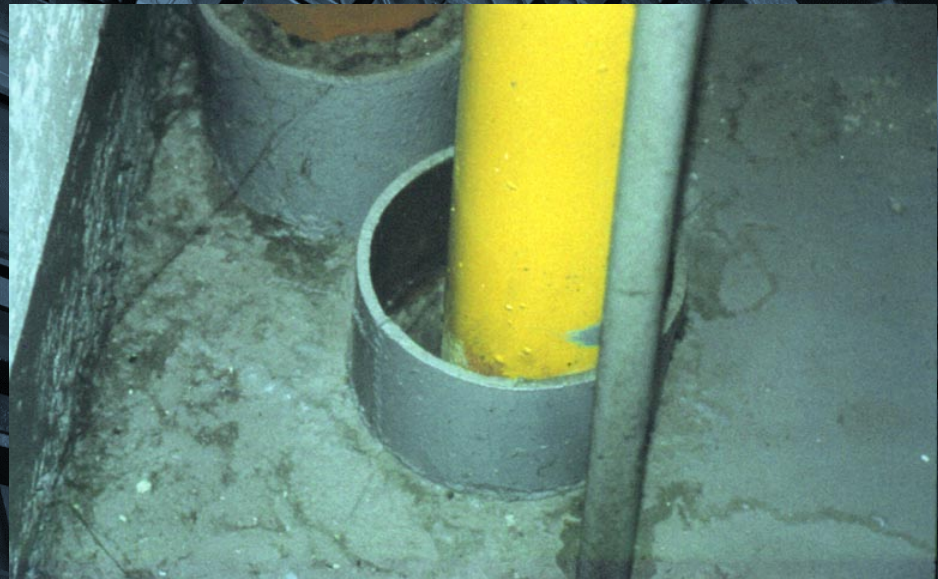
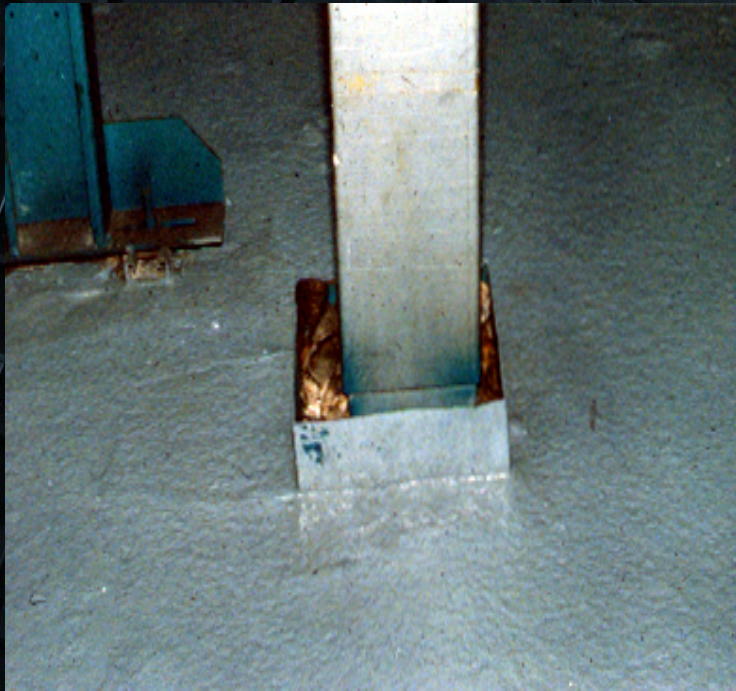
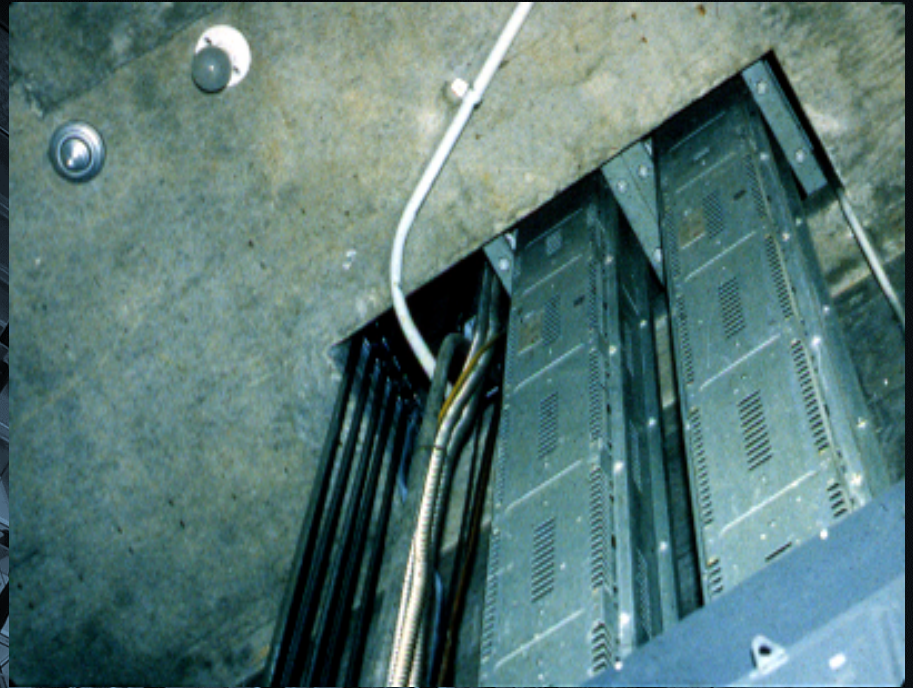
Seal the shafts

- Stairwell fire doors
- Fire hose cabinets
- Plumbing, electrical, cable and other penetrations within service rooms
- Elevator rooms- cable holes, door controller cable holes, bus bar openings
- Garbage chute perimeter and access hatches
- Hallway pressurization grille perimeters
- Smoke shaft access doors
- Elevator shaft smoke control grilles
- Mechanical & electrical shafts
